INSPECTION / ASSESSMENT REPORT

‘STABLES’ 33 ISABELLA STREET, WINGHAM, TAREE.

Re: Inspection of the fire damaged ‘charred structure’ - Stables Report and assessment on its condition in relation to the likelihood of the Structure being a danger to the public.

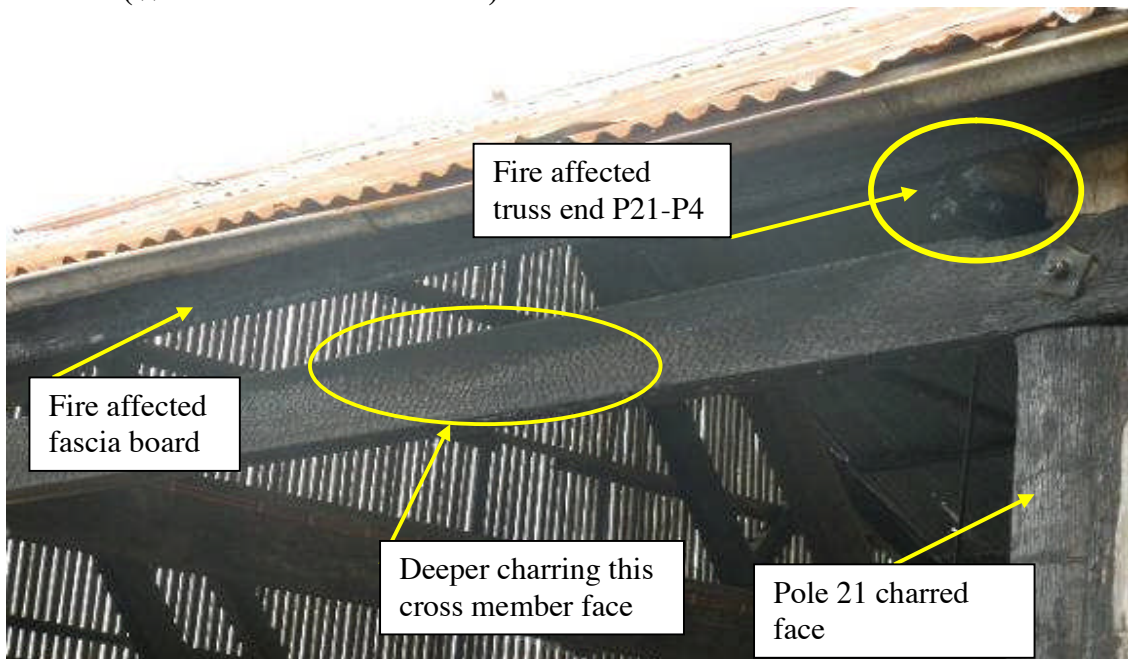
Photo 7. (Western –fire affected side)

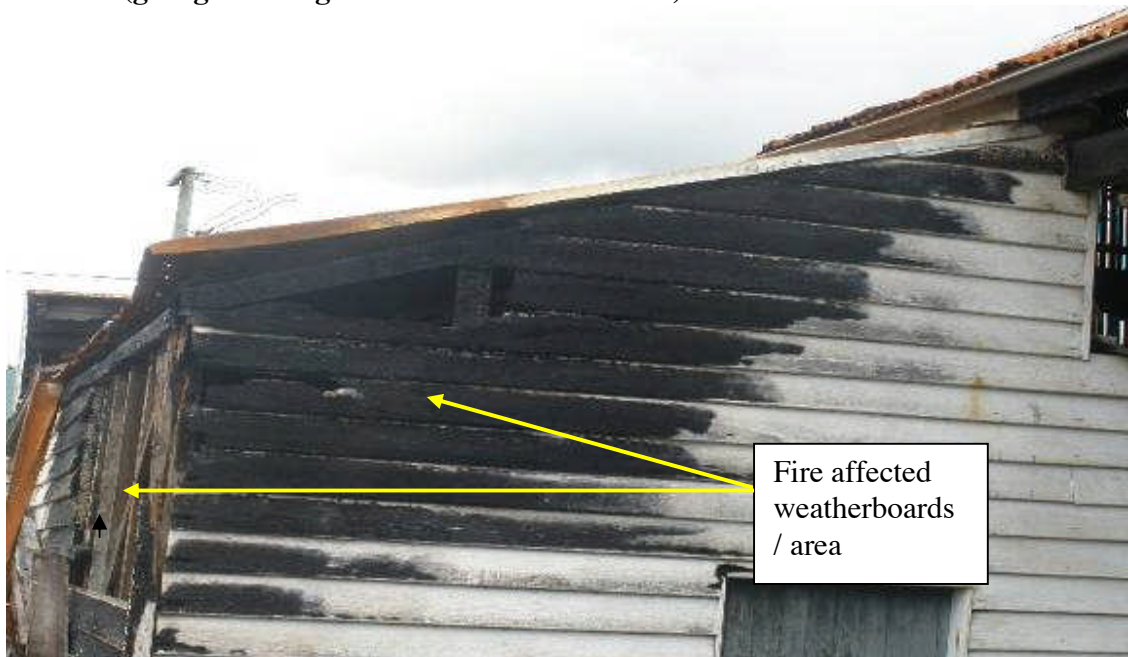
Photo 8. (garage / storage extension –Western cnr.)

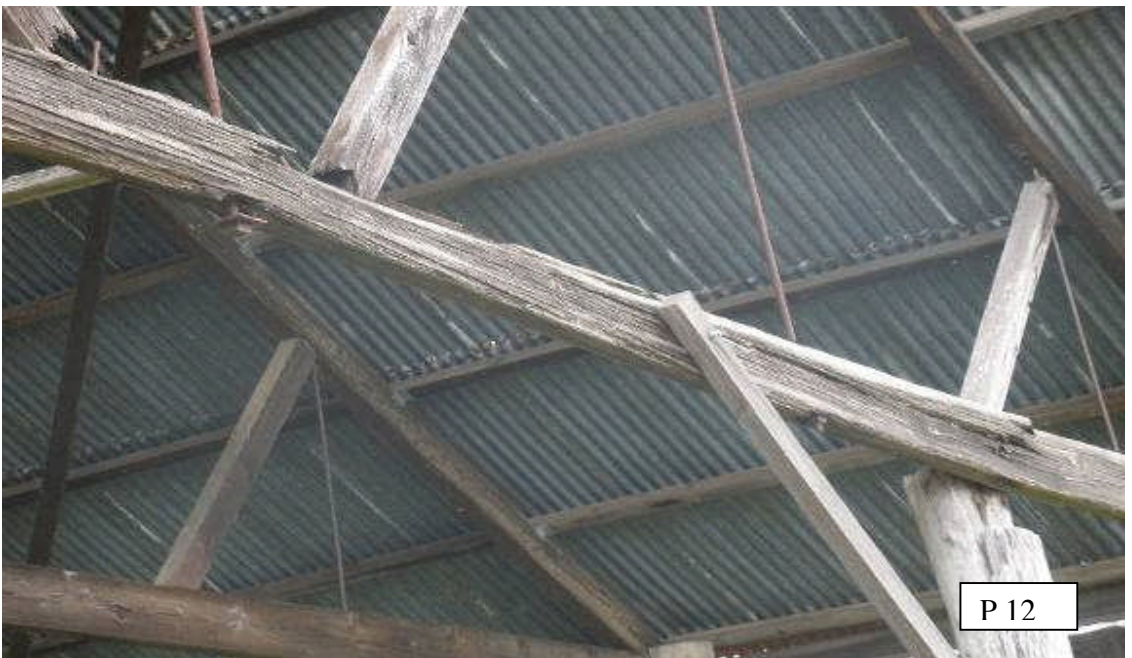
6. Truss P14-P11 is under threat of collapse. The bottom chord is significantly deteriorated and tension and compression members have failed or are failing

Photo 14. Eastern End Failed Truss (P11-P14) immediate remedial works required

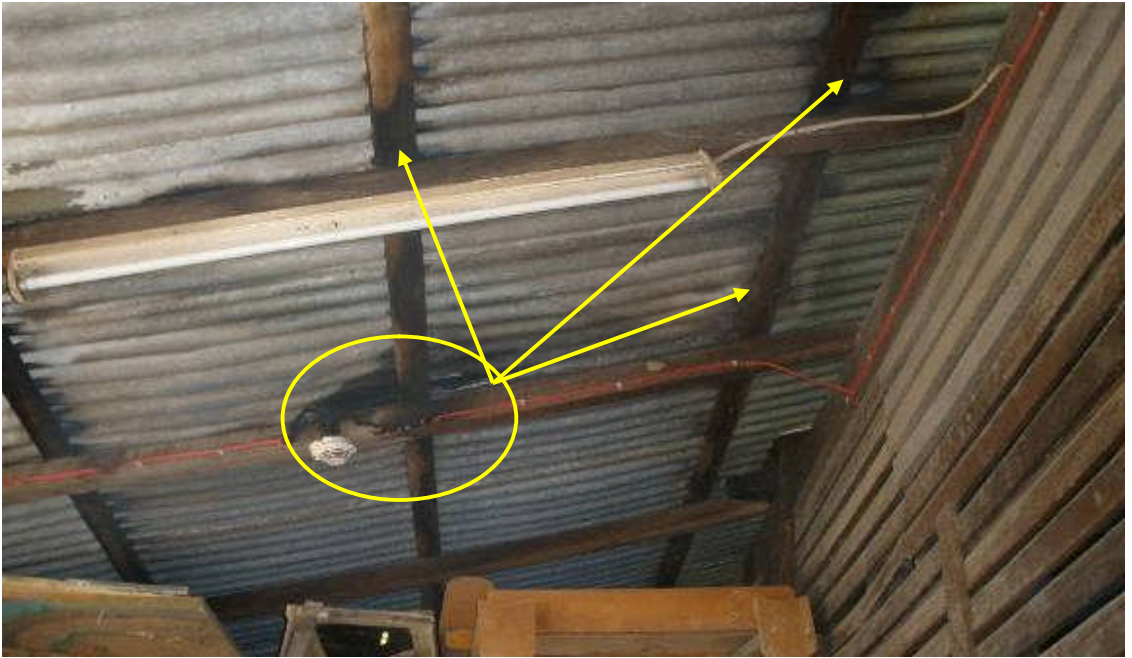
Photo 17. Garage /storage internal minor fire affected roof battens

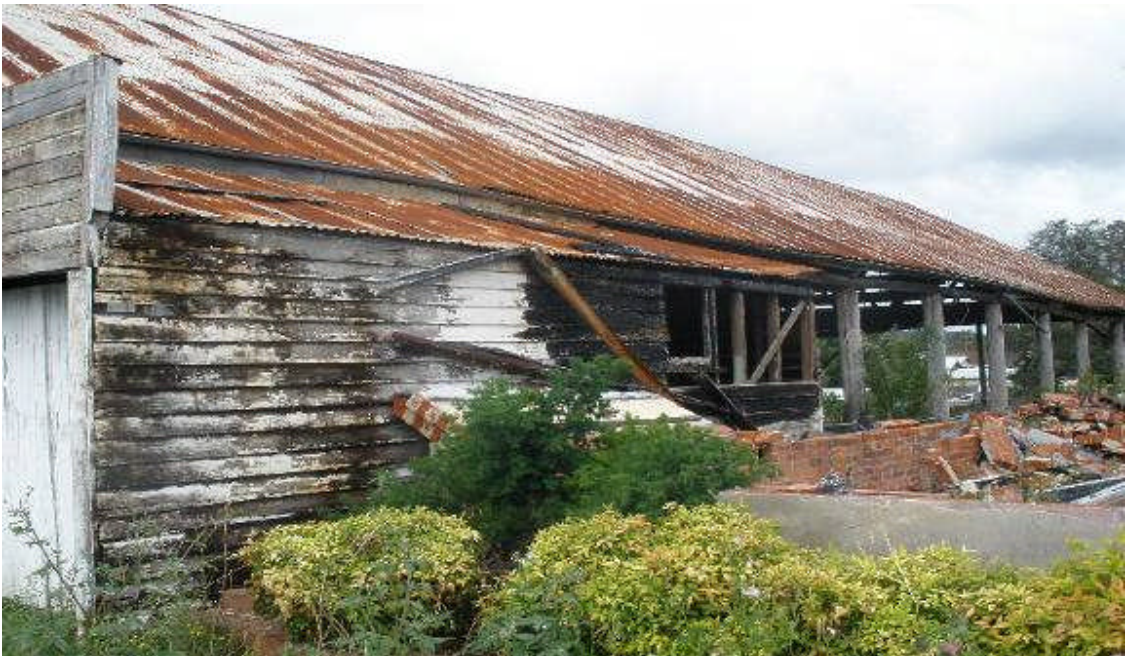
5. Significant 'charring damage' to the fascia board P21-P22 and evidence of section loss
6. Significant 'charring' to weatherboards on the Western sides of the garage / storage area

Photo 18. Fire affected weatherboards

5. There was significant ‘charring’ to weatherboards on the Western sides of the garage / storage area. The cladding and framing do not appear to be impacting on the structural integrity and safety of the Stables. However a more intrusive investigation of the construction needs to be carried out before partial or complete removal (these works do not really ‘tell a story’). If removal is to occur a photographic record should be undertaken and sketches made of both sides of the boards.

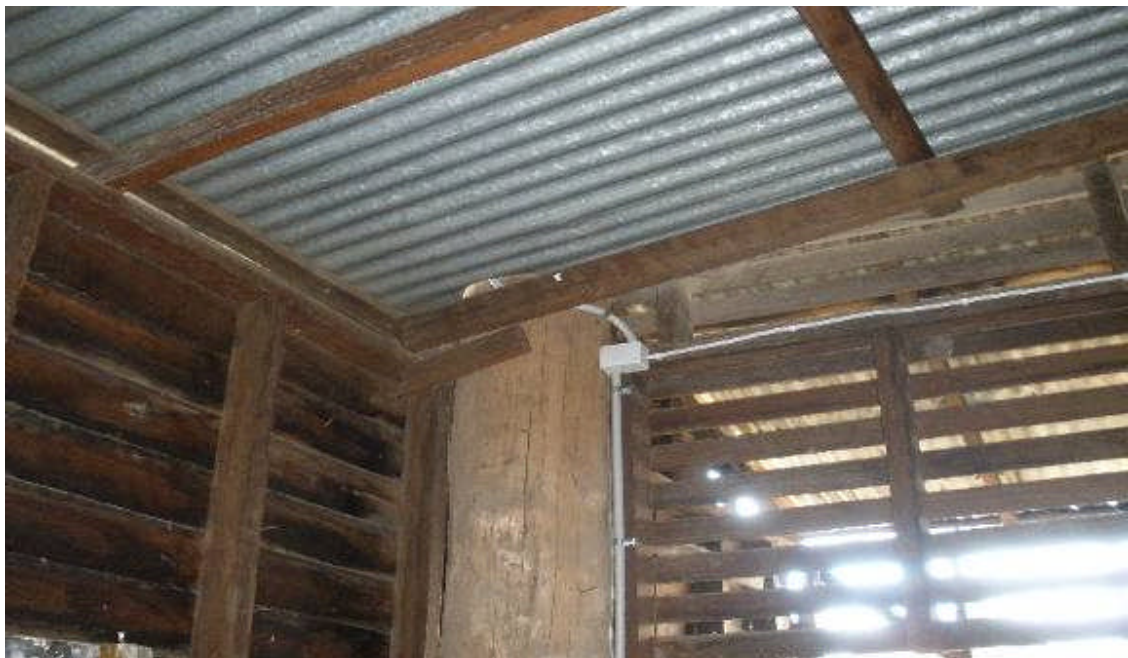
Photo 19. Internal of garage / storage –assessment of the construction to be made with main structure (poles) to be determined if removal of addition being considered?
